ARCHITECTS'S FIELD REPORT

STATE PARK	Arkansas State Parks	Notice to Proceed – 27 July 2021	
	Lake Dardanelle State Park	100 Contract Days to 26 Sept 2002	
Project	Visitor Information and Education Center	25 July 2003 Substantial Completion Date	
Contractor:	Johnson Engineering, Inc.	Phone	
Office Contact	Don Johnson	Phone	
Project Manager		Phone	
Job Superintendent		Phone	
Architect / Engineer	The Borné Firm Architects, P.A.	Phone	
DBA Inspector		Phone	
DBA # 0003.15		Contract Amount \$2,297,000.00	
State Park# 07BF98103			
Date of Visit	2022-08-09		
Friday, Aug 9, 2022	Weather Condition	sunny	Temp: 90°
	People on site – 5

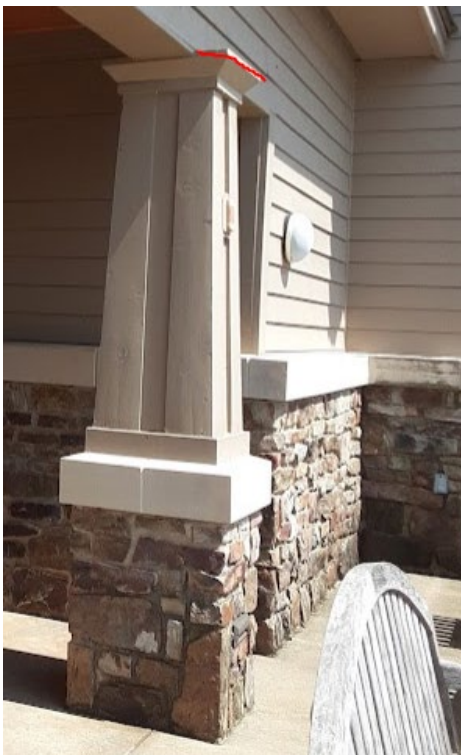
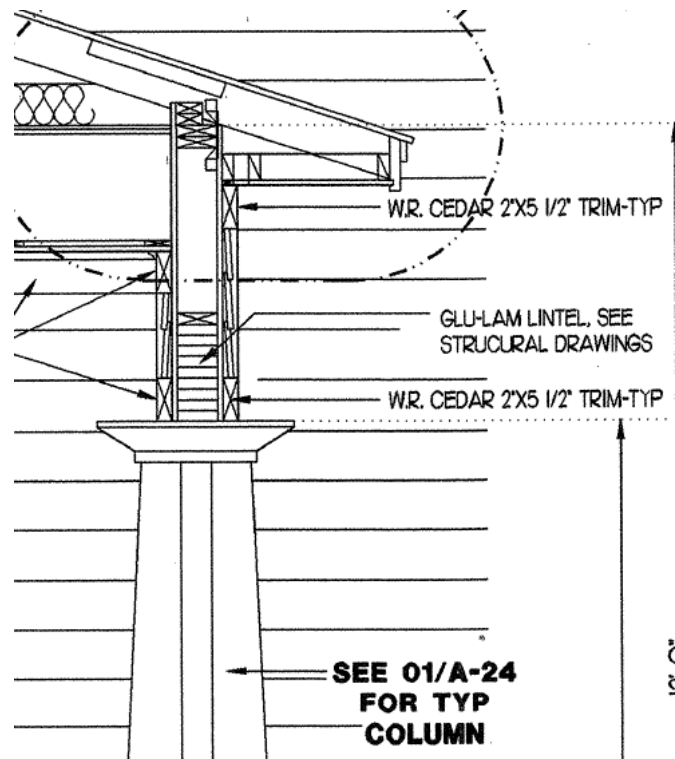
Below is a photo of the column at the observation deck with the construction section for the column to the right. There was no flashing at the top of the column, and the weather coming off the lake wasn't taken into consideration that water would get to area, but it has and over the years that has caused rot at the column, with water evidence being seen at the underside of the decking in this area where it has been dripping down to the crawl space. Work is in progress to add flashing to the top of these columns.

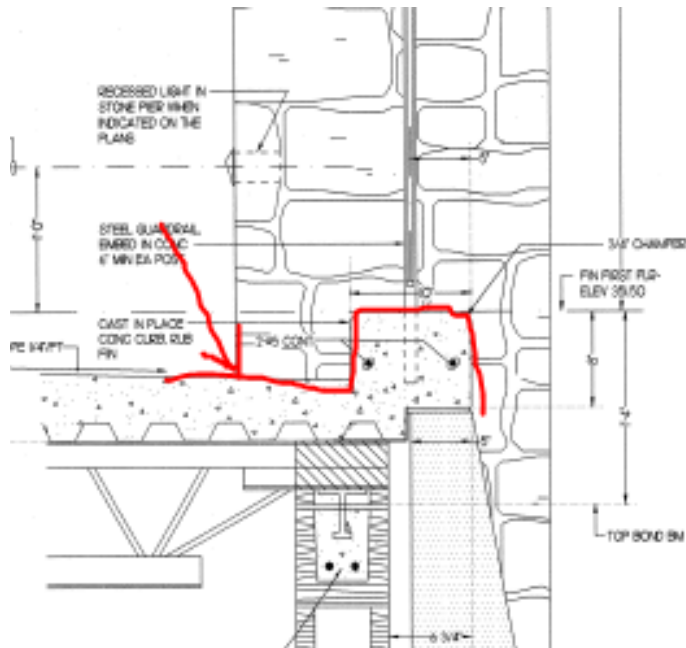
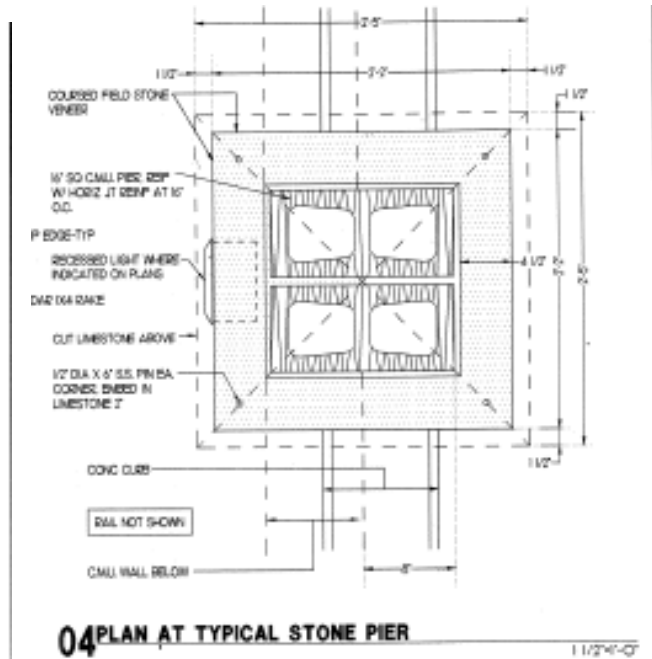
At the short columns at the perimeter of the observations deck, there is water coming through them. I'm not finding in the drawings any verification that the cast in place concrete curb that I have outlined in red below is continuous through the column. The detail of the column to the right does suggest that the curb is not continuous. What is now happening is that water is getting behind the rock and making its way down to the crawl space. A solution for this may be to add a bead of caulk along the base of the rock, where it meets the concrete deck (indicated by the red arrow.)

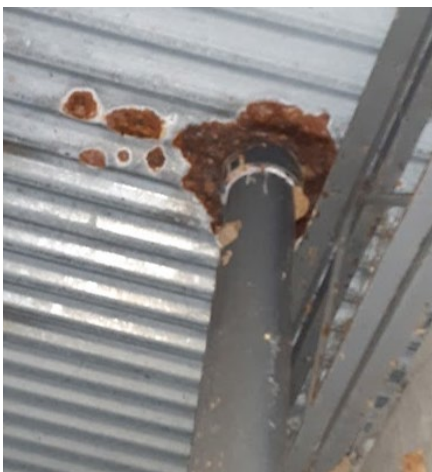
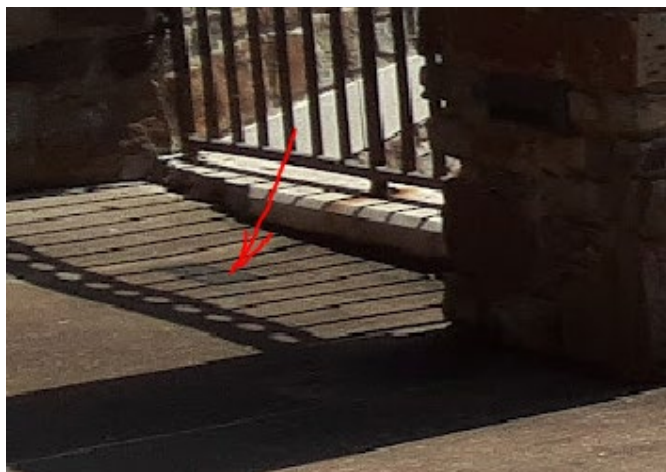
At the underside of the concrete decking, at the drain locations, there is evidence of water damage. Water could be seeping between the drain and the concrete, and this area could be caulk. The top can be taken off and a bead of caulk can be applied to the lip that may prevent water from getting between the drain and the concrete.

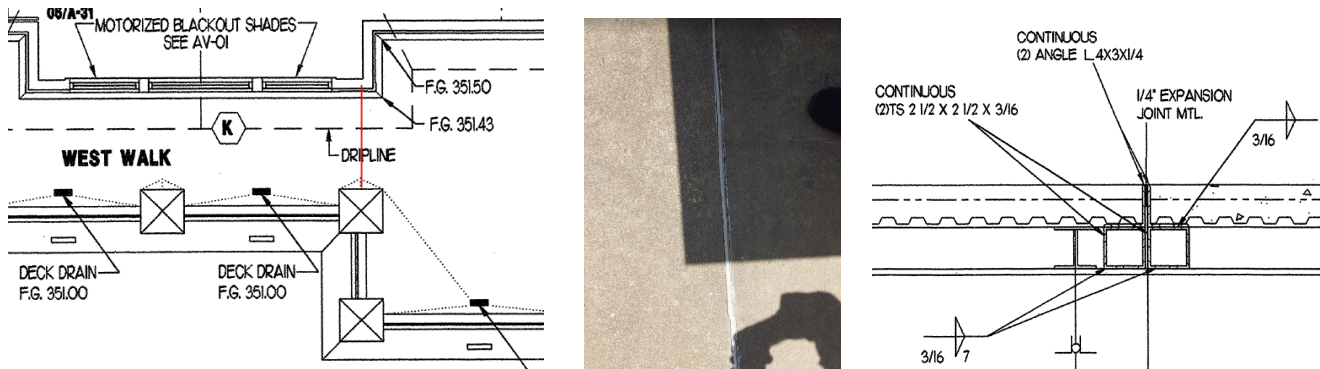
At the transition between the west walk and the observation deck, floor plan for reference, there is a construction joint that doesn't show up in the drawings, shown in red. The support joist change directions at this point, so this detail is similar to another detail that is shown on the drawings. The water seepage to the crawlspace may be the greatest at this point, and the joint needs to be maintained with the proper caulking process on a regular basis. It was done by a contractor approximately five years ago.

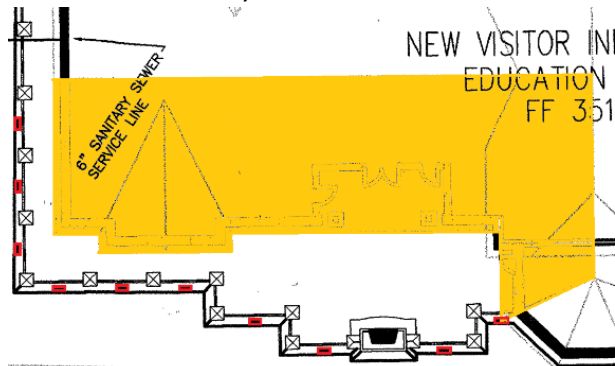
About thirty percent of the roof drains onto the observation deck and the west deck and there are no gutters. I propose gutters that will have a down spout that is cored through the deck and then connects with the existing wall spout to drain to the exterior. Do to the volume of water and the size of the existing outlets, we will need to size a holding pipe to control the flow to the exterior while being able to contain the volume of water that is coming off the roof.

The area shaded in yellow is the area that drains to the observation deck and the west walkway, with the existing drains at the deck shown as the red squares.

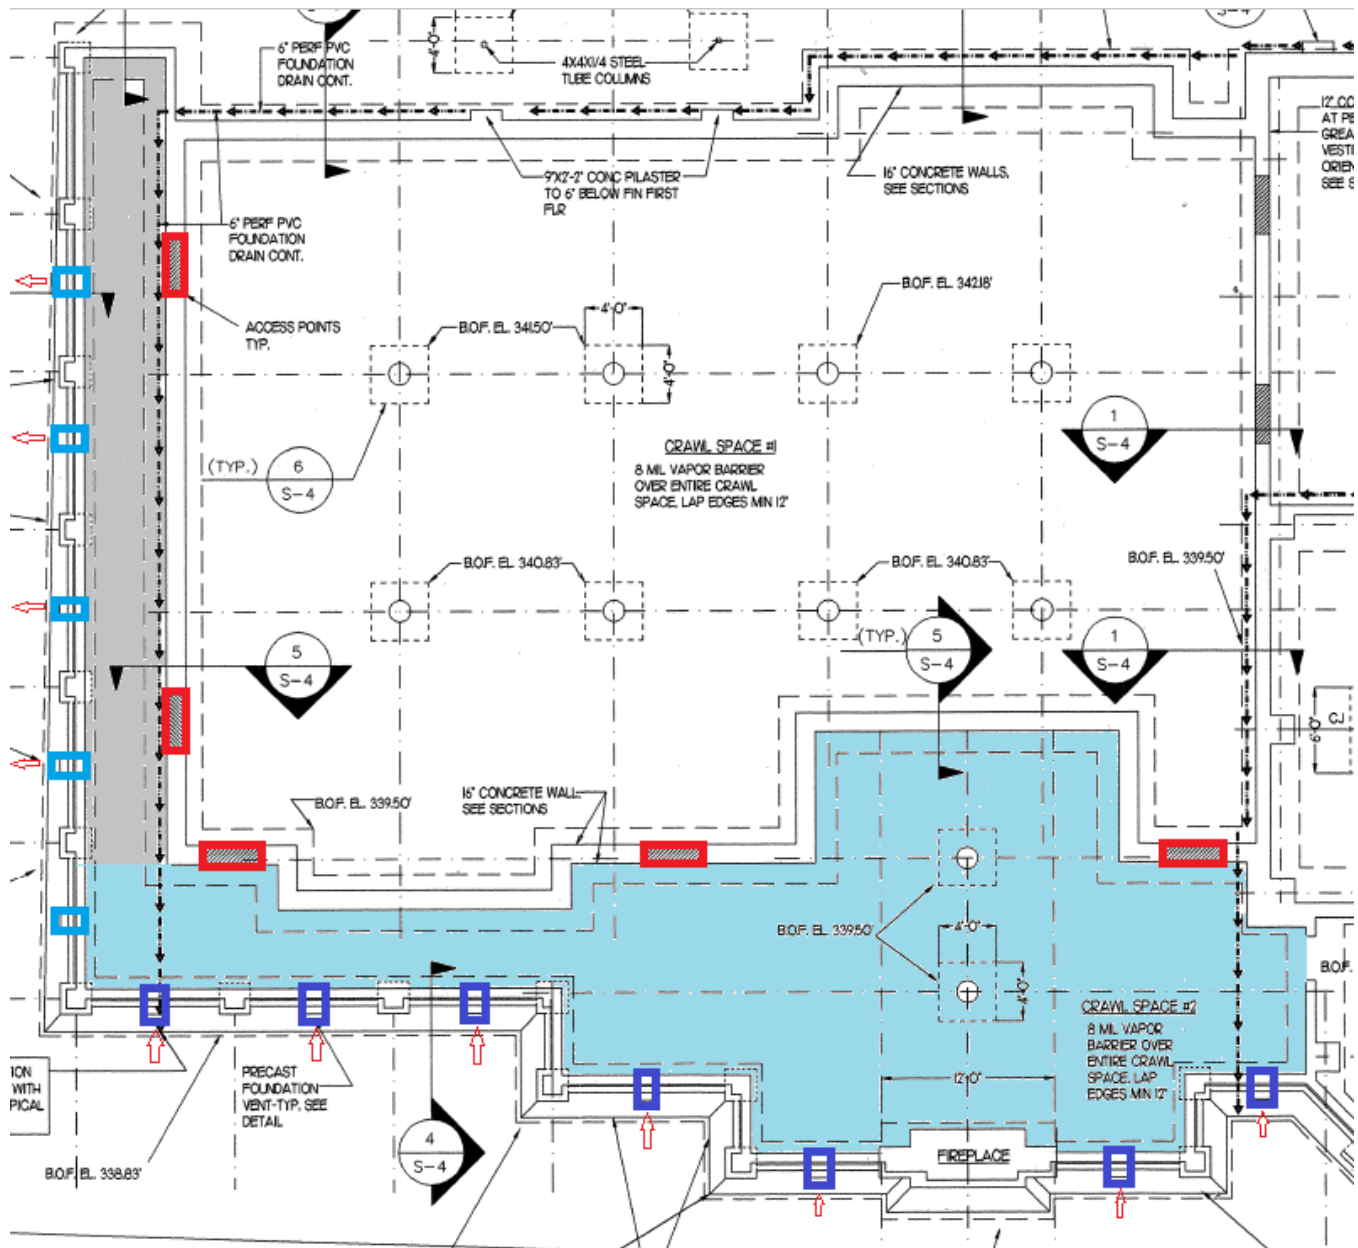
At the crawl space the plans called for all areas to have an 8 mil vapor barrier, but at the area colored light blue in the image below, there is only exposed dirt. The area shaded in gray, has the vapor barrier as well as gravel. The light blue area needs to have the vapor barrier installed as well as a layer of gravel. Also on this image, the darker blue squares on the left of the plan are the ventilation openings with the decorative grill that is seen at the exterior. To reduce the amount of moisture in the crawl space, exhaust fans could be installed at the vents under the north walk. This would draw air from the vents on the west side to ventilate the space. There are several openings to the greater part of the crawlspace that would need to be covered up with a simple frame and plywood to minimize air being drawn from those areas. The openings are show below as red squares.

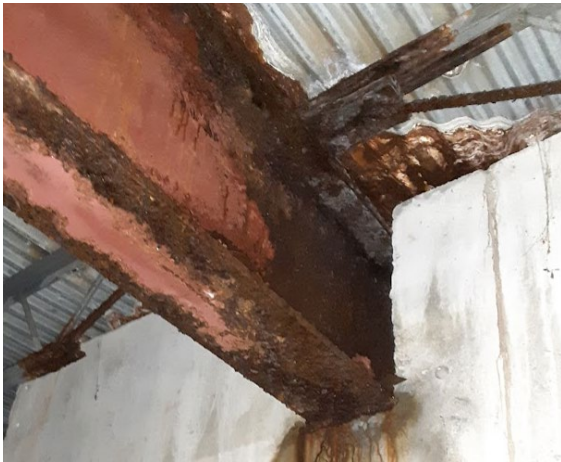
Photo: beam that is centered on the fireplace above.

The rust that is seen at the underside of the decking needs to be dealt with by removal, cleaning, and primer

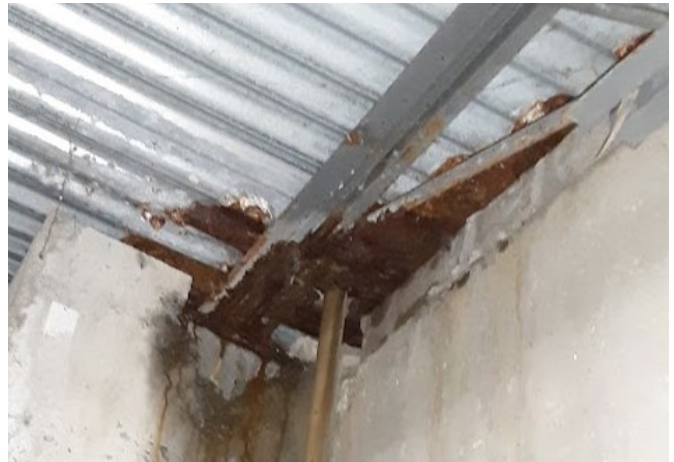
Photo: right side corner of fireplace from below.

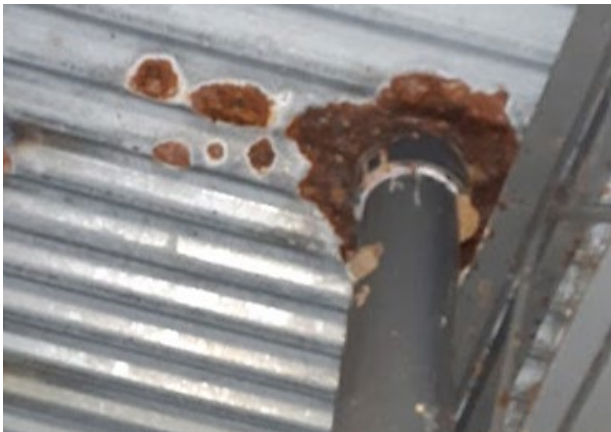
Photo: rust at underside of decking at drain lines.

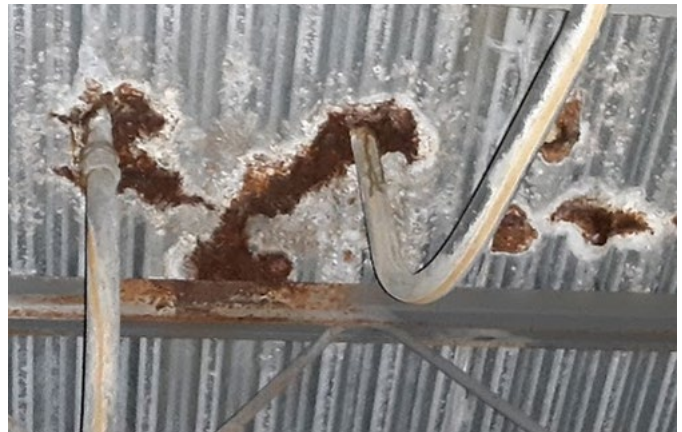
Photo: view of decking below the columns at porch.

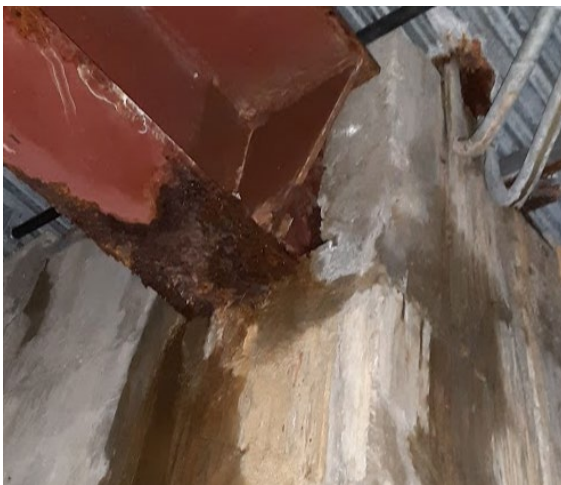
Photo: beam to outer wall to south of fireplace.

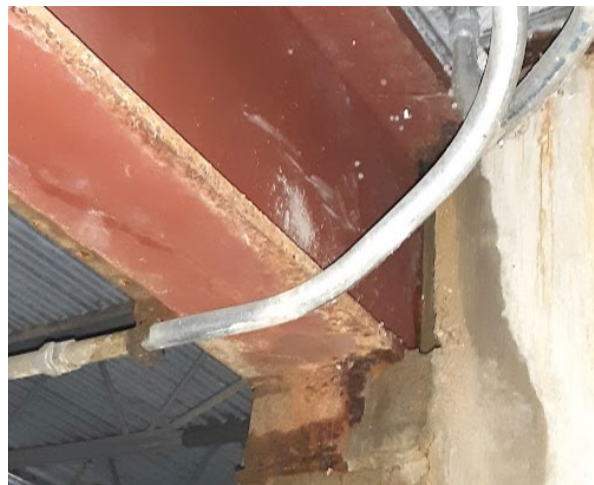
Photo: beam to outer wall to north of fireplace.
