**RE: INDOOR AIR QUALITY INSPECTION OF  
EACC PRESIDENTS HOUSE  
M & A PROJECT #3315-22**

**EACC  
PRESIDENT'S HOUSE  
FORREST CITY, ARKANSAS  
APRIL 8, 2022**

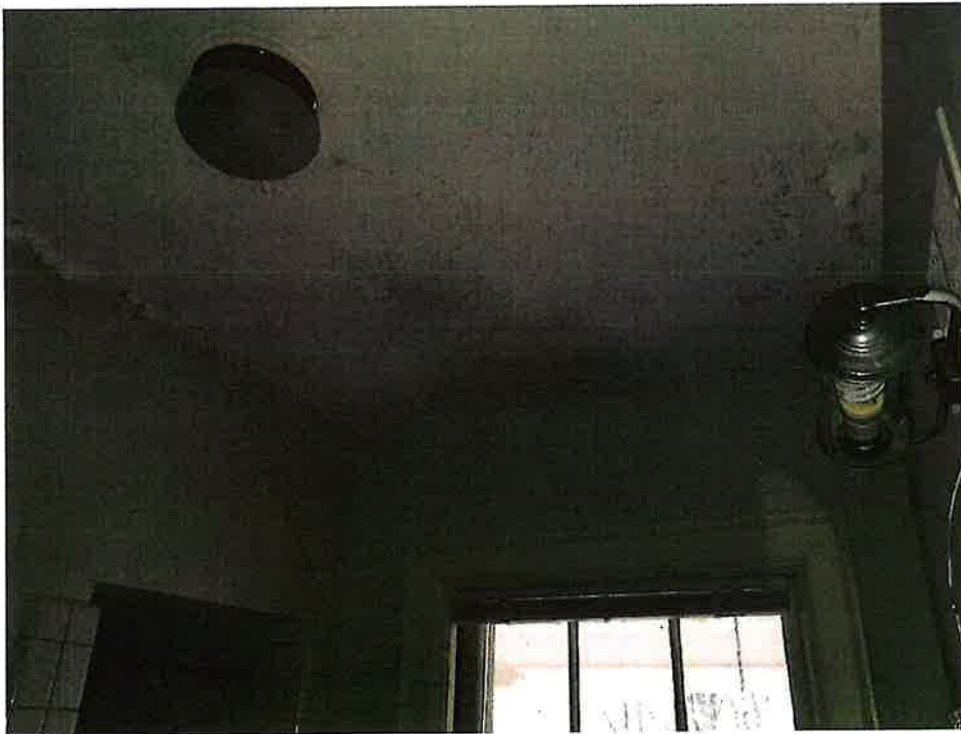
2<sup>ND</sup> FLOOR MASTER BATH.  
VISIBLE MOLD GROWTH  
ON CEILING.

During the investigation I walked through the building with Tanner McKnight with EACC. 1. The master bathroom is the first area we inspected. I feel the mold growth is caused from moisture coming from the shower. Upon further investigation in the attic area above the master bathroom the insulation has been moved and allowing the ceiling to become cooler than other areas. 2. The mold growth areas in the stairwell to the attic are associated with the duct work that runs in the wall behind the plaster. This area is shown on the thermal image in this report. Additional insulation should be added to duct work to stop the thermal transfer through the wall. When the HVAC is in cooling mode the wall is cooled and exposed to non-conditioned air in the attic. This is allowing moisture and mold to grow on the surface of the wall. The areas of mold growth were detected by visual inspection and with the use of Thermal Imaging and Bore Scope cameras. We also did an inspection of the two HVAC units in the basement area. Only one unit was running at the time of the inspection. A HVAC technician should inspect these units to insure they are operating properly. The basement dryer vent is being exhausted to the mechanical room of the basement. This is allowing warm moist air to be introduced into the basement and HVAC units. This needs to be routed to the outside of the building. 3.

5.  
It is my recommendation that a remediation be performed to remove the visible mold growth and clean the basement area. This work should be performed by a properly trained remediation contractor. Additional air testing should be performed once the remediation is complete.

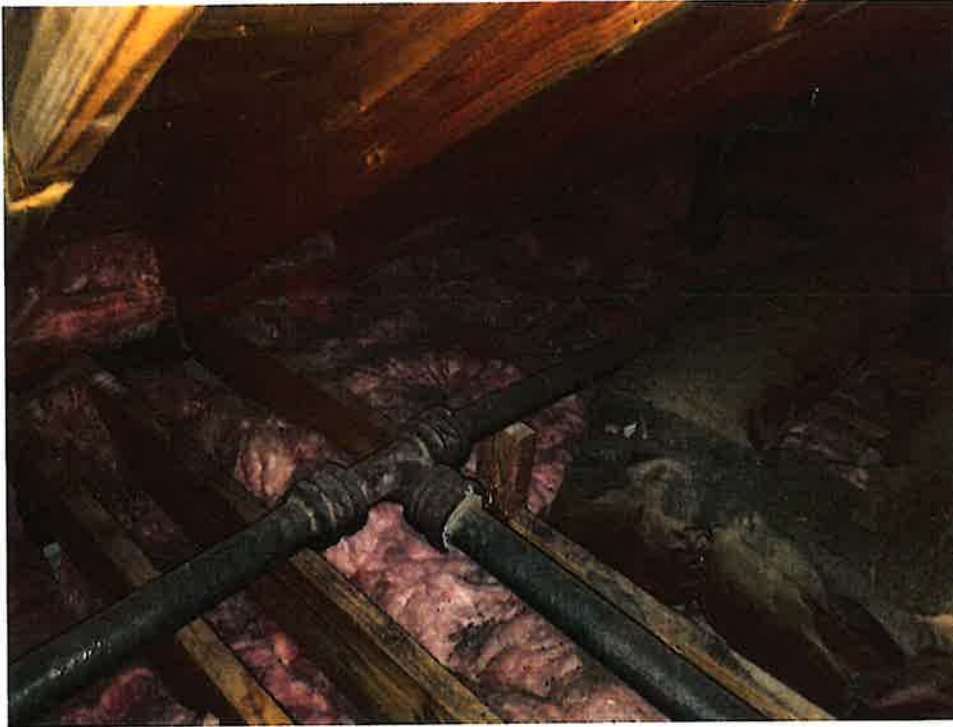
3.

ATTIC AREA ABOVE  
MASTER BATH.  
FIBERGLASS INSULATION  
IS NOT COVERING THE  
BATHROOM CEILING. THIS  
IS ALLOWING  
UNCONDITIONED AIR TO  
COOL THE PLASTER  
CEILING.

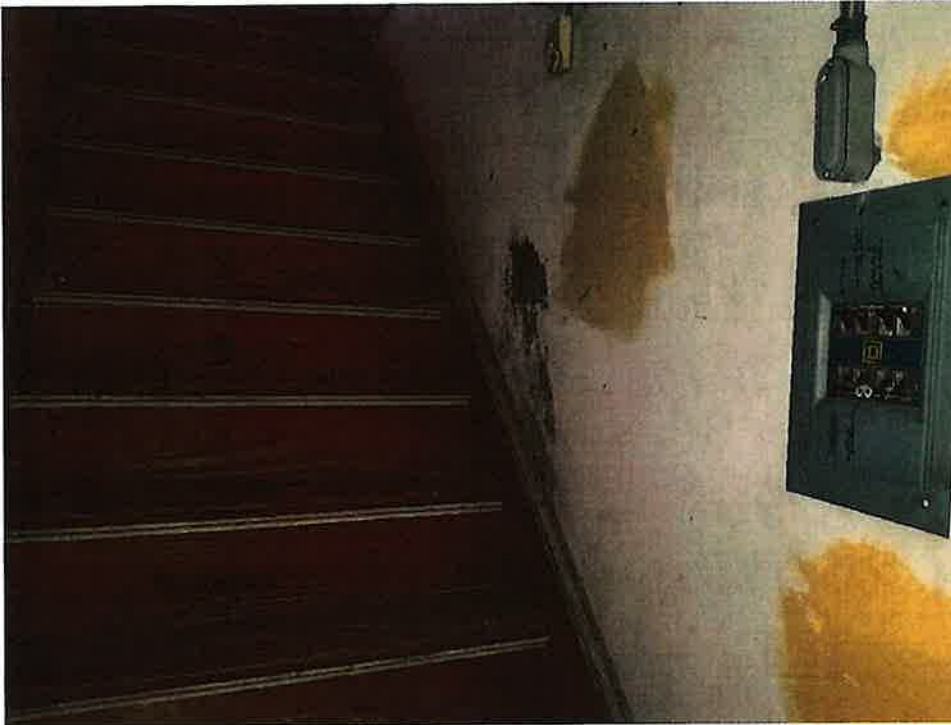
5.

STAIRWELL TO ATTIC  
WEST HALL. THERE IS A  
SMALL AREA OF MOLD  
GROWTH. THE SAME  
CONDITION EXISTS IN THIS  
AREA AS EAST WALL.

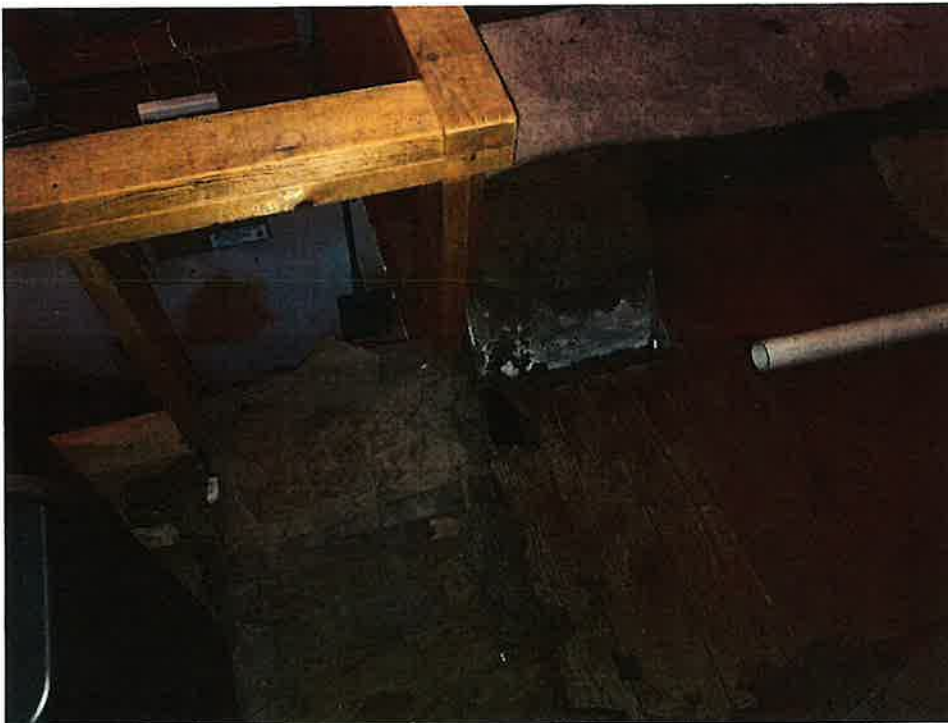
6.

THESE ARE THE TWO  
DUCTS THAT ARE IN THE  
WALL CAVITY SHOWN IN  
PHOTO #4. THE  
INSULATION IS DAMAGED.

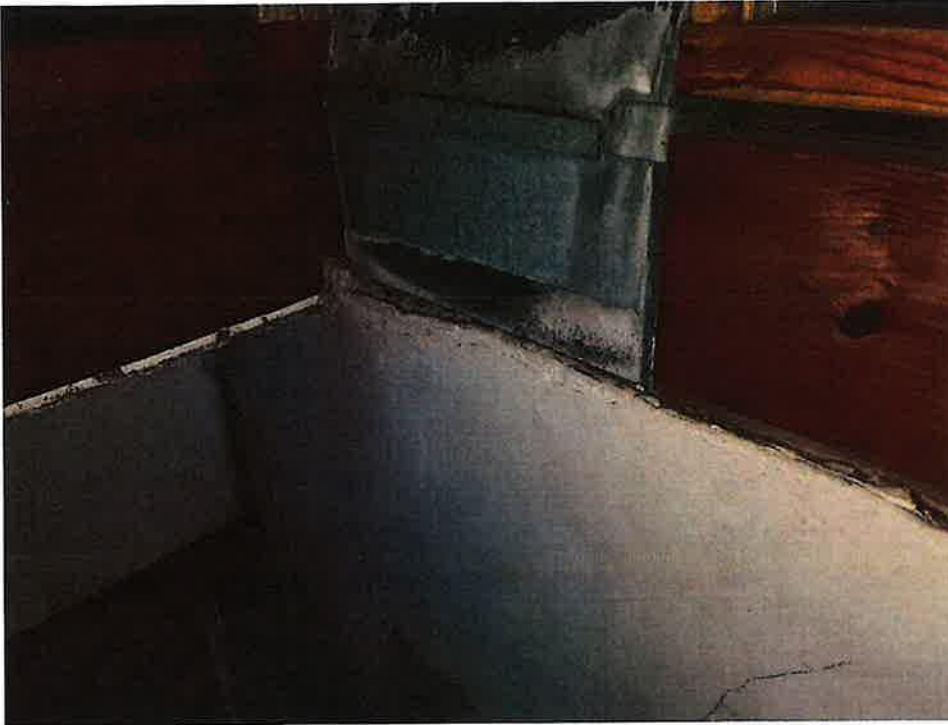
7.

EXTENDED VIEW OF PHOTO #6. THE PAPER INSULATION ON THE DUCT CONTAINS 50% CHRYSOTILE ASBESTOS THERE IS ALSO SMALL AMOUNT OF MOLD GROWTH ON ASBESTOS PAPER INSULATION.

During the inspection I also collected samples of the paper insulation from the exterior of the ductwork. The samples were analyzed for presents of asbestos. The samples revealed 50% chrysotile asbestos. The material should only be removed by certified personnel. 4.

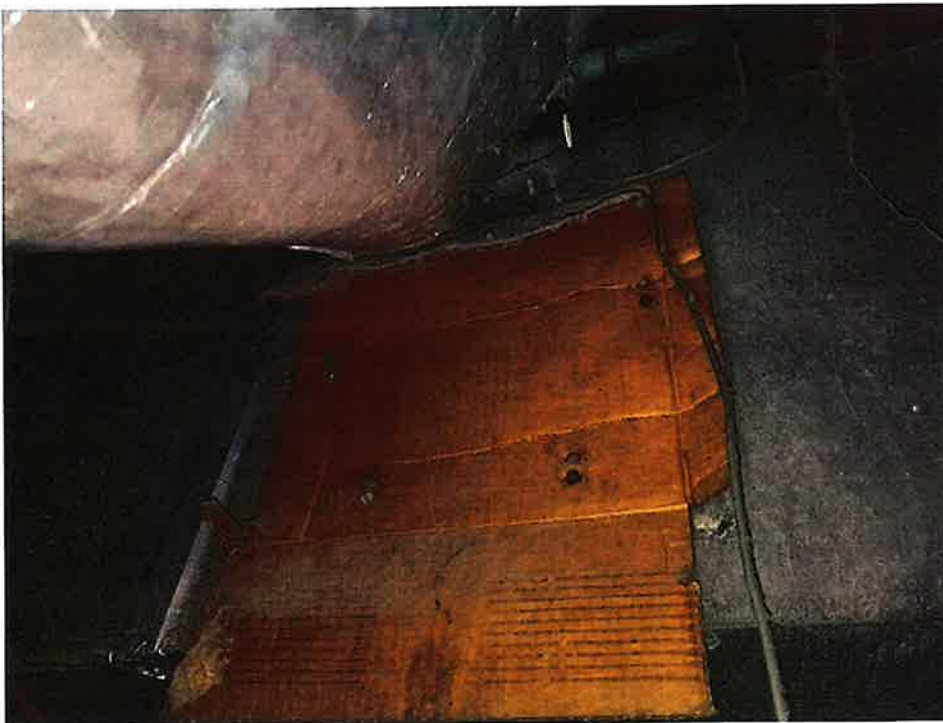
8.

BASEMENT. DUCT MAIN TRUNK HAS CARDBOARD USED TO COVER AN OPENING.

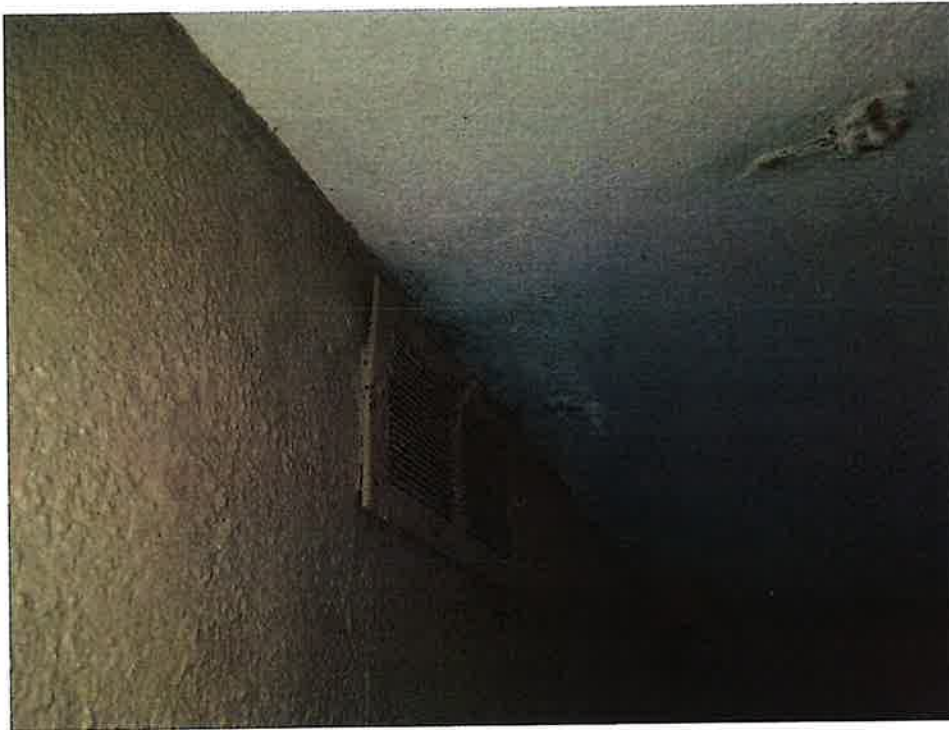
9.

BASEMENT. SMALL  
AMOUNT OF MOLD  
GROWTH ON CEILING AT  
HVAC VENT.

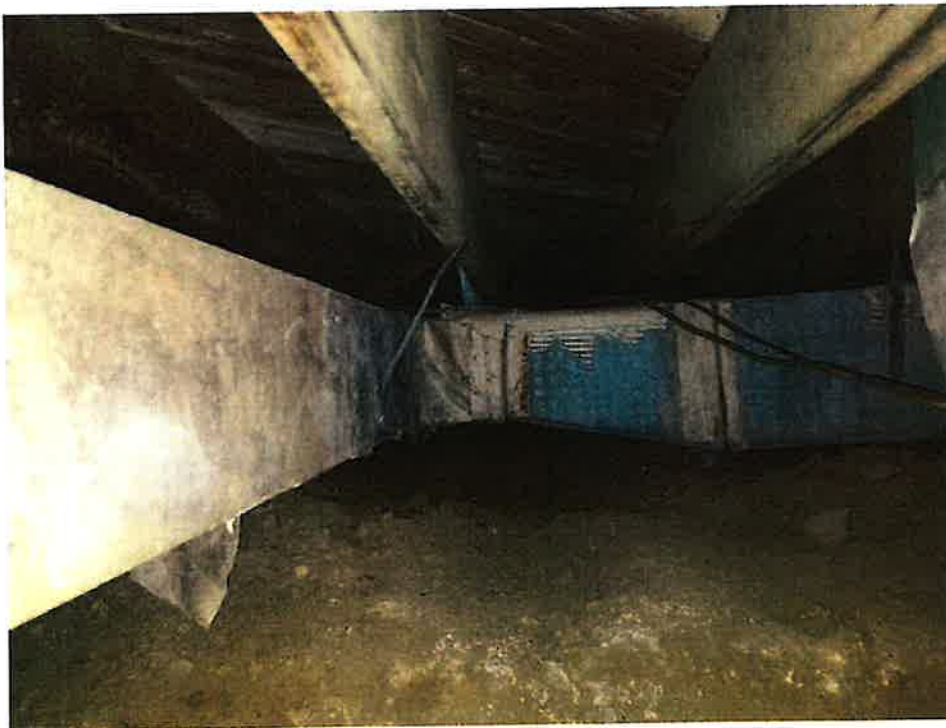
10.

CRAWL SPACE.  
DUCTWORK WITH  
ASBESTOS CONTAINING  
PAPER INSULATION.

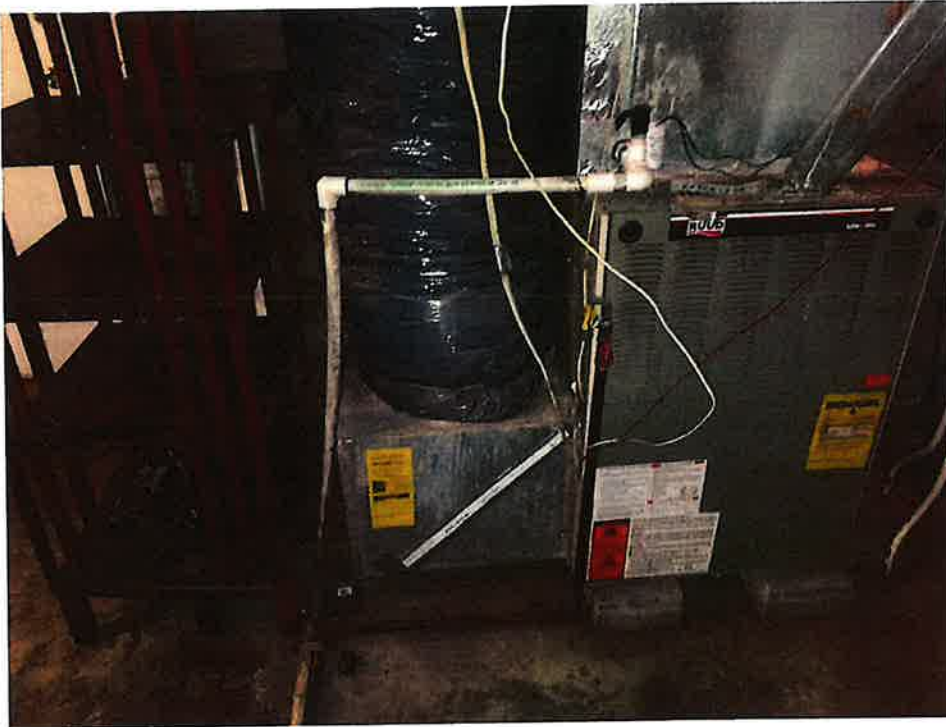
11.

BASEMENT SOUTH. HVAC  
UNIT FILTER HOUSING  
NEEDS TO HAVE SEAL OVER  
FILTER. THIS IS ALLOWING  
UNFILTERED AIR PAST  
FILTER.

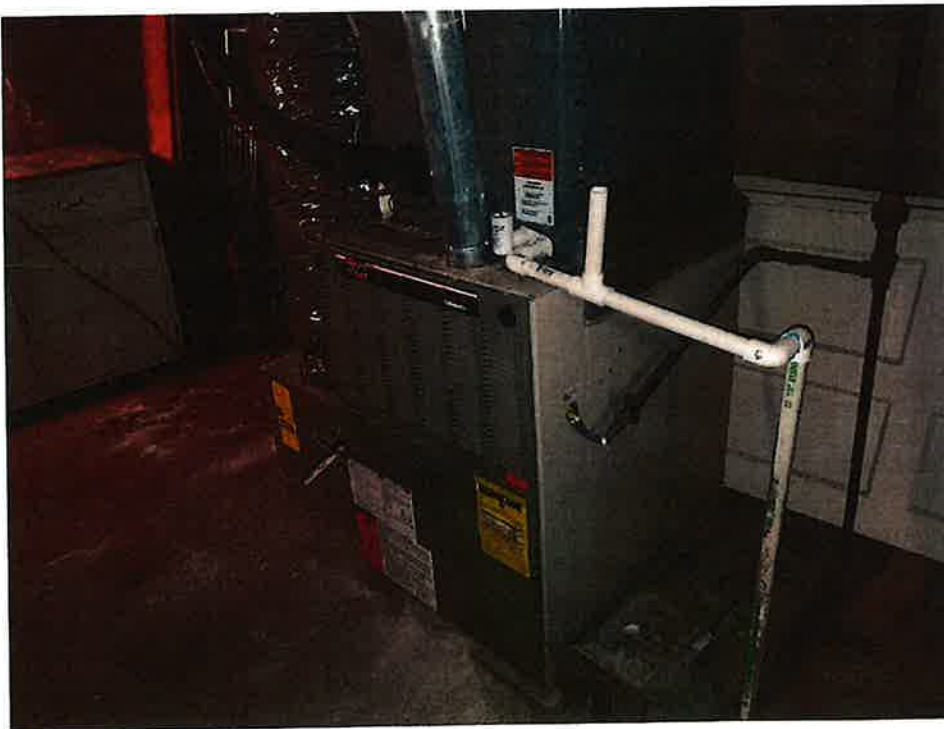
12.

BASEMENT NORTH HVAC  
UNIT. SAME CONDITION  
AS SOUTH UNIT.

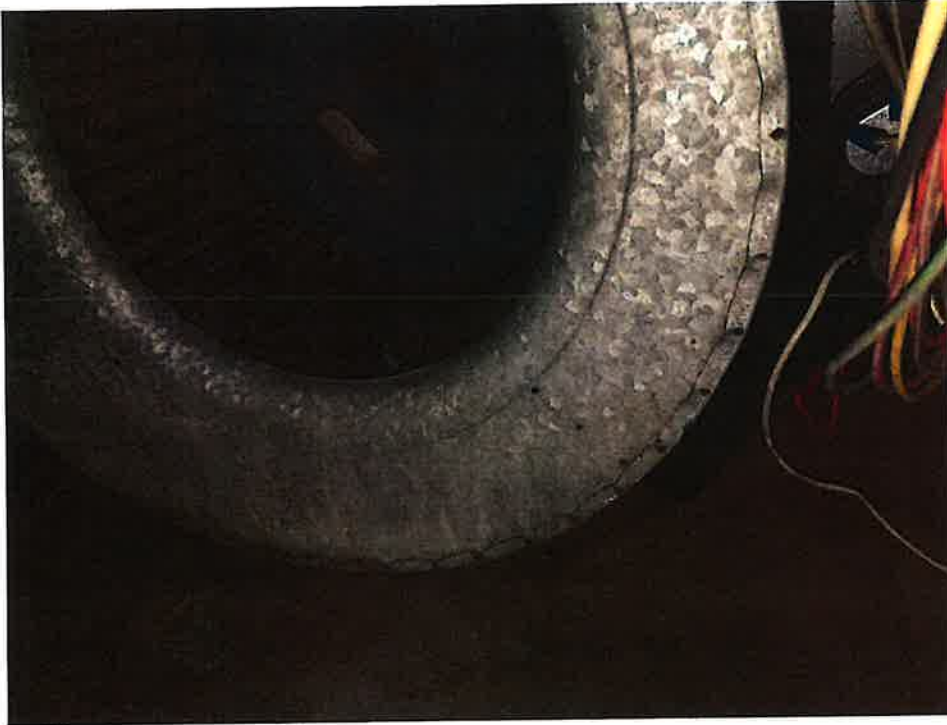
13.

BASEMENT HVAC UNIT  
BLOWER SEEMS TO BE  
FAIRLY CLEAN.

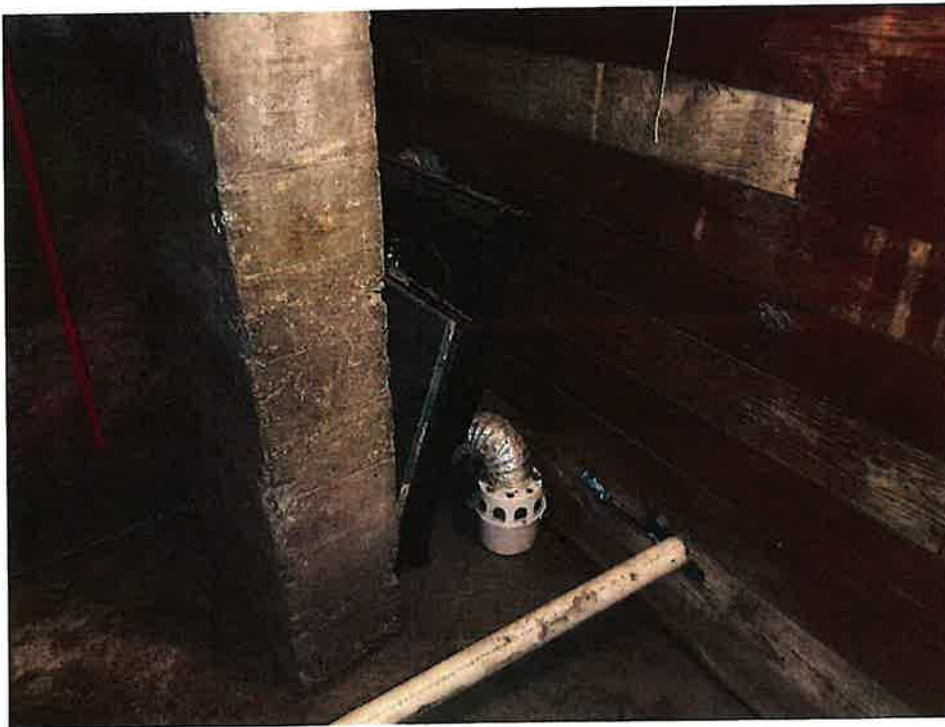
14.

BASEMENT DRYER VENT IS  
EXHAUSTING INTO  
MECHANICAL ROOM  
WHERE BOTH HVAC UNITS  
ARE. THIS IS ALLOWING  
MOIST HUMID AIR INTO  
THE ROOM AND POSSIBLY  
INTO THE HVAC UNITS.
